REPORT OF MARINE SURVEY

"Maggie Tulliver"

JIM BROWN 31' Trimaran

SURVEY SUMMARY:

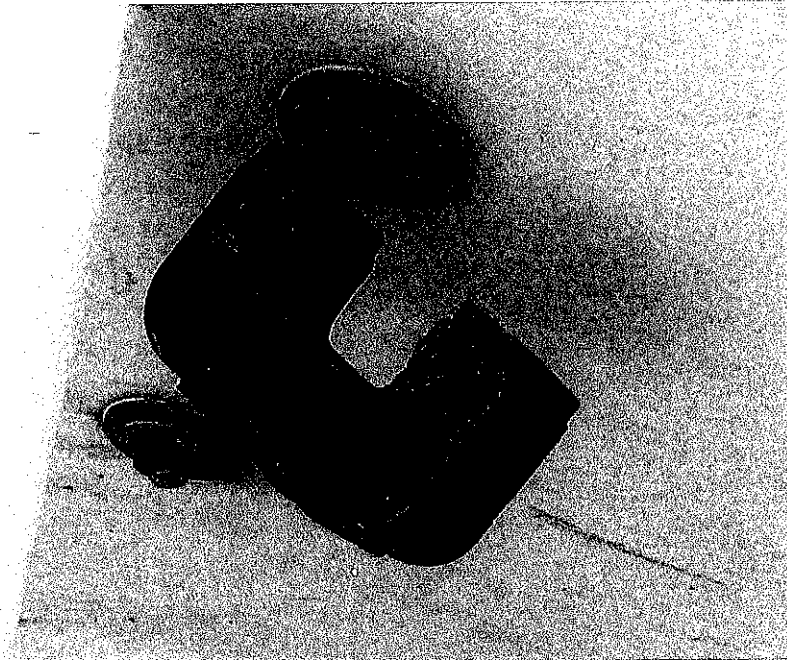
Figure 1 Port and starboard forward beam underside. The bolts need to be replaced with stainless bolts.

1. Figure 1 Repair Items. Forward beams , port and starboard have a ferrous nut that is corroded and should be replaced.
2. Figure 2 Repair items. Several bolts on the A frame starboard side are ferrous and should be replaced with a stainless version.
- * 3. Figure 3 Repair items. Port side steering cable turning block is lifting off its support. Tighten the bolts .
4. Starboard and port hatch gasket is compressed due to age and considerations should be given to replacing with a rubber bulb style gasket.

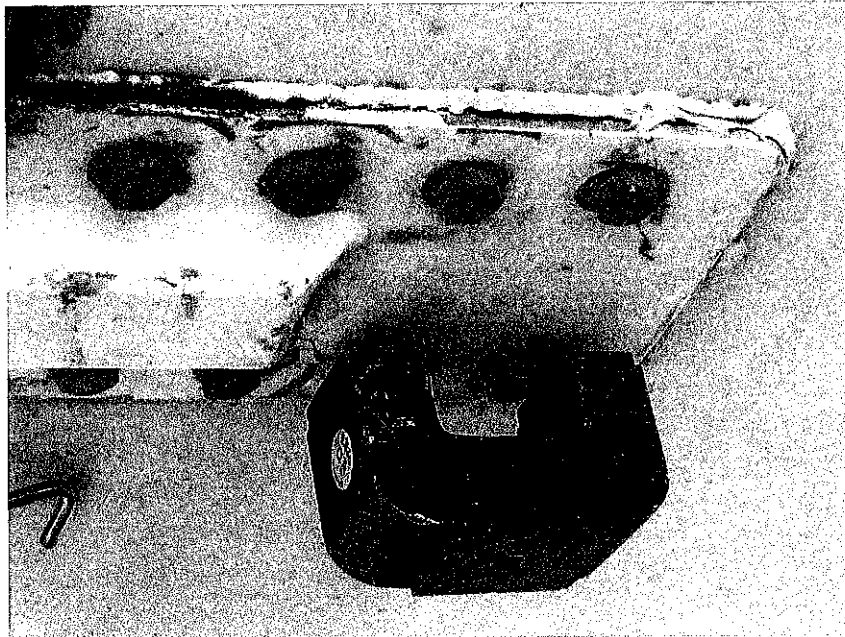
Figure 2 Ferrous bolts should be replaced with stainless. This piece is on the starboard "A" frame under side.
