## Original

## Repaired

# Repair procedure

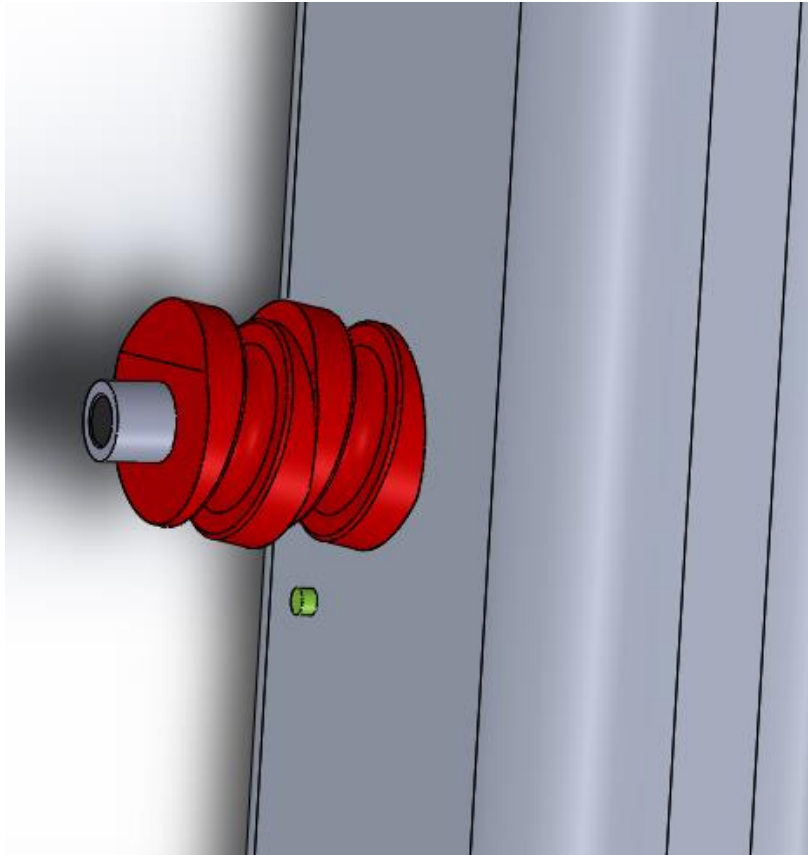
Original

Doubly cantilevered design

One fastener taking all bending load

<30ksi yield strength for the fastener

Compression tube not designed to react any moment

.156" wall thickness, aluminum

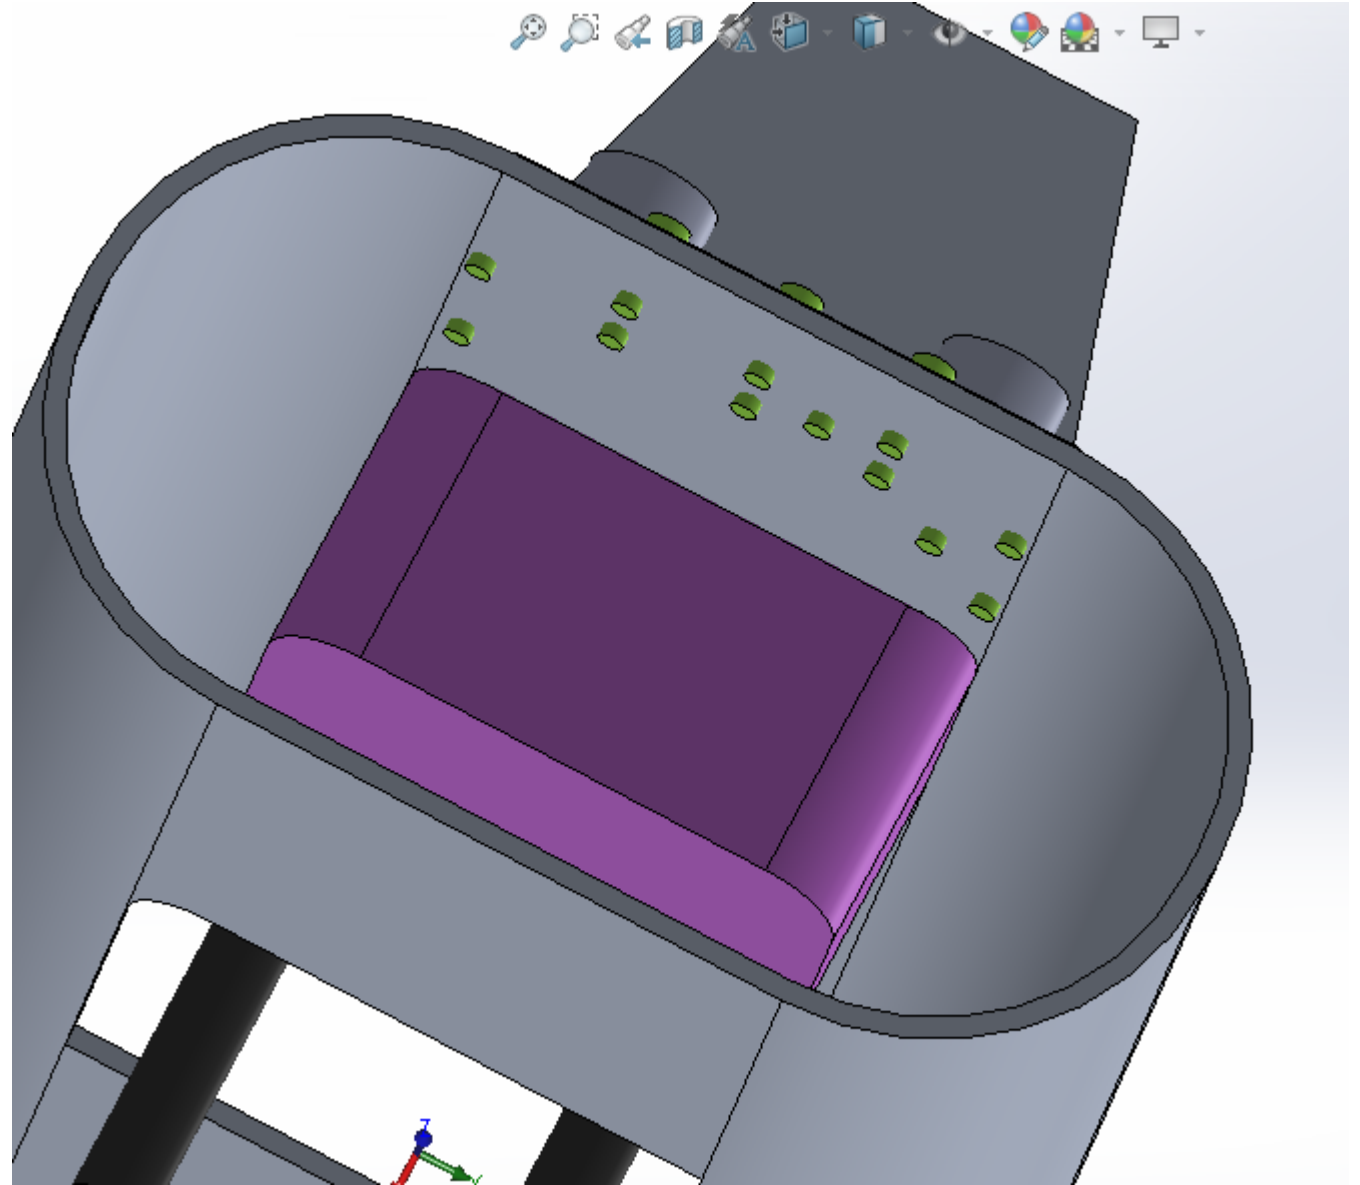
- Seems unlikely due to the way the fortunate way the compression member will force halyards/wiring to be routed fore and aft
