TURNCOUPLE IMPACT TEST PICTURES

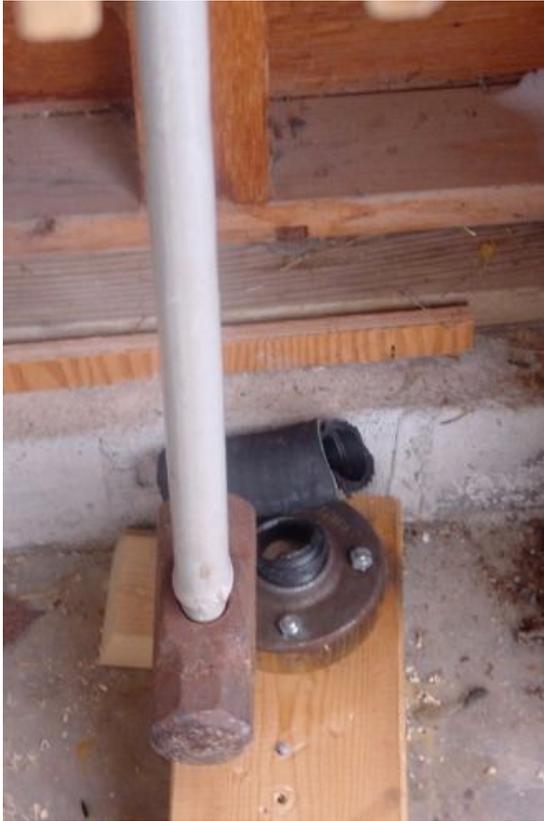
The Picture 1 shows my pendulum impact device. The cast iron threaded flange was mounted with 4 carriage bolts and attached to a 2x6 pressure treated board. The 8 lb hammer had a 33" handle and was raised to a horizontal position and released. The hammer was raised 90 degrees and let go.

Schedule 80 PVC lasted 1 hit. The Marelon fittings lasted two hits. Picture 1 is a Marelon fitting; notice how cleanly it sheared. As a comparison, bronze is good for 6-8 hits.

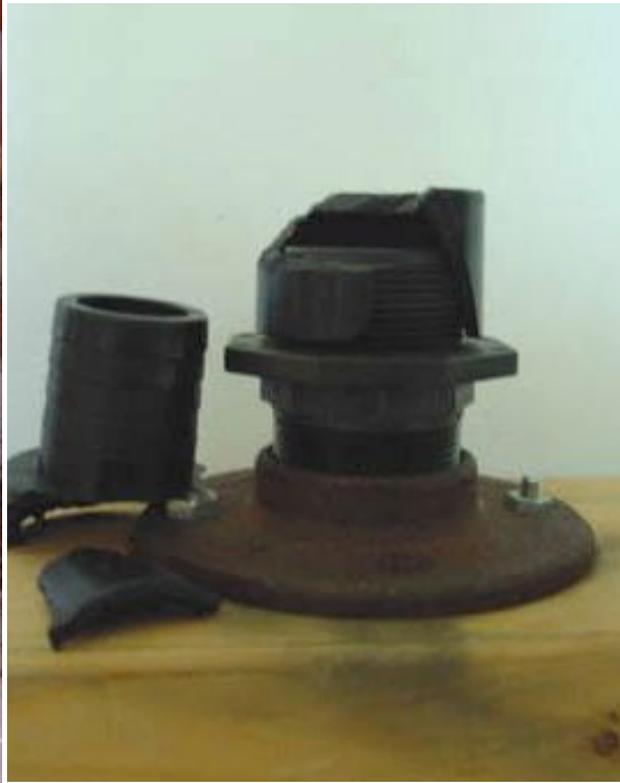
The nipple fitting in Picture 2 is a Turncouple part (with black added when molded), the female barbed fitting was a Marelon part that went 2 hits also. The Turncouple nipple survived at least 100 hits while testing other female fittings and Turncouples. It showed no cracking or thread distortion.

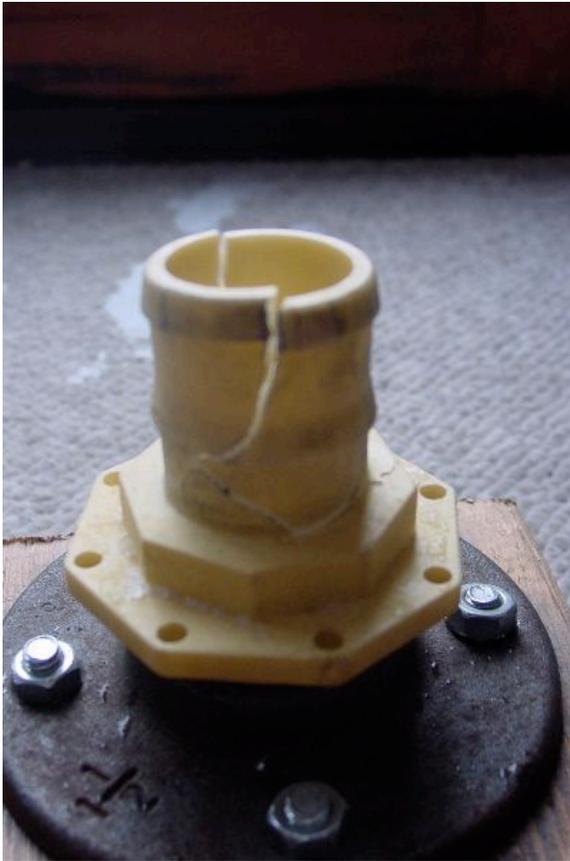
Picture 3 shows a Turncouple barbed fitting after 18 hits. The Turncouple is molded using a 20% long glass filled Thermopolyurethane (TPU). This Turncouple was molded with 20% long glass fiber and exceeded the H-27 Tensile Strength and Flexural Modulus requirements. Several non-glass loaded Turncouple tailpieces were tested sustaining 13 hits before cracking. This material does not meet the ABYC material standard, but had over six times the impact strength as Marelon.

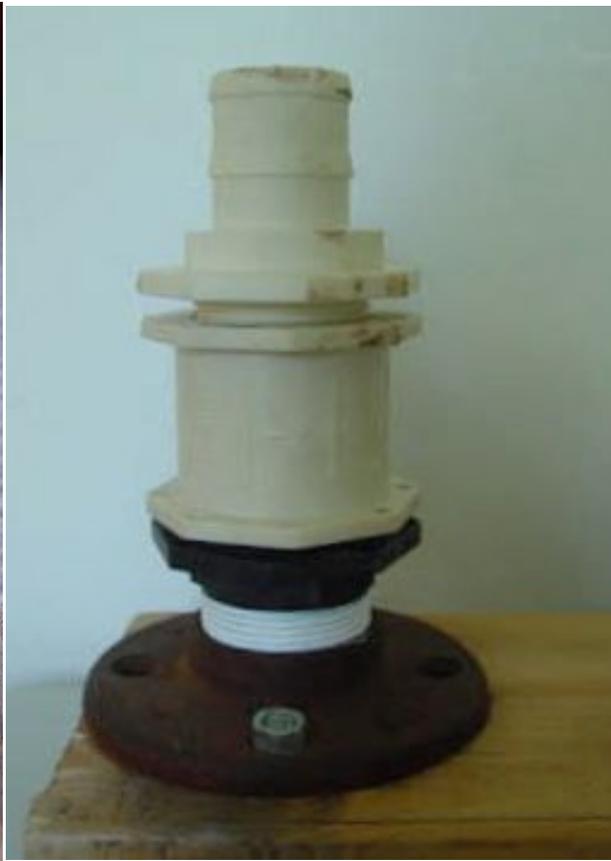
The Picture 4 shows a full Turncouple assembly after 50 hits. It has no cracks, especially where the nipple threads screwed into the cast iron flange. It was still functional. The highest impact value I was able to get testing any other material was 3 hits using a 33% glass loaded Dupont nylon of our own manufacture.

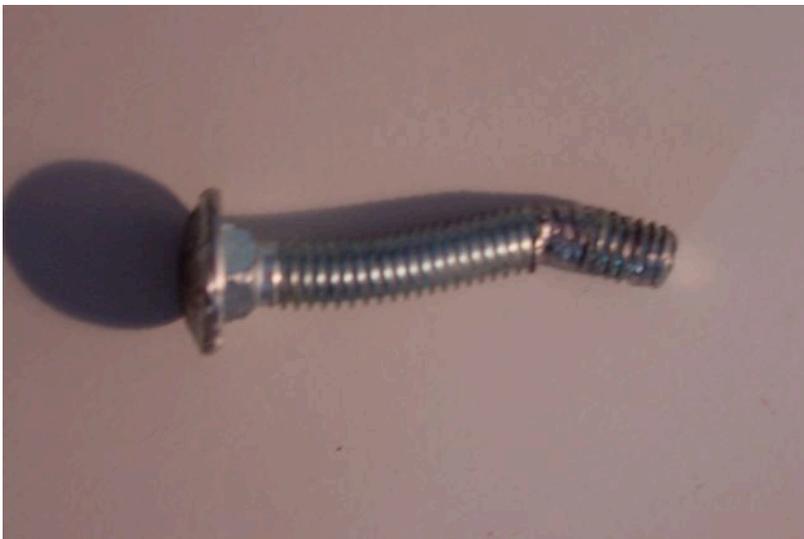
Picture 5, is one of the carriage bolts after the tests were finished. It clearly, shows the impact strength of TPU and the quality of the Turncouple molded threads.

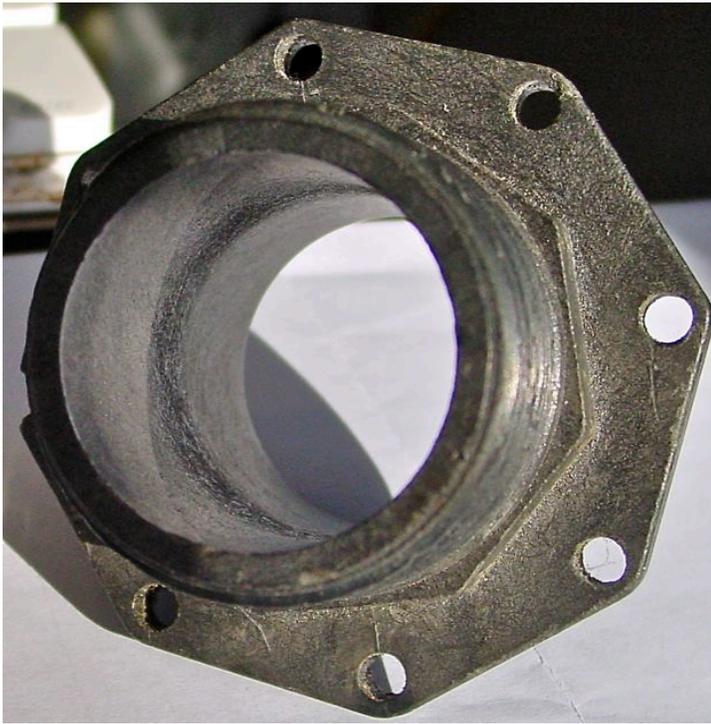
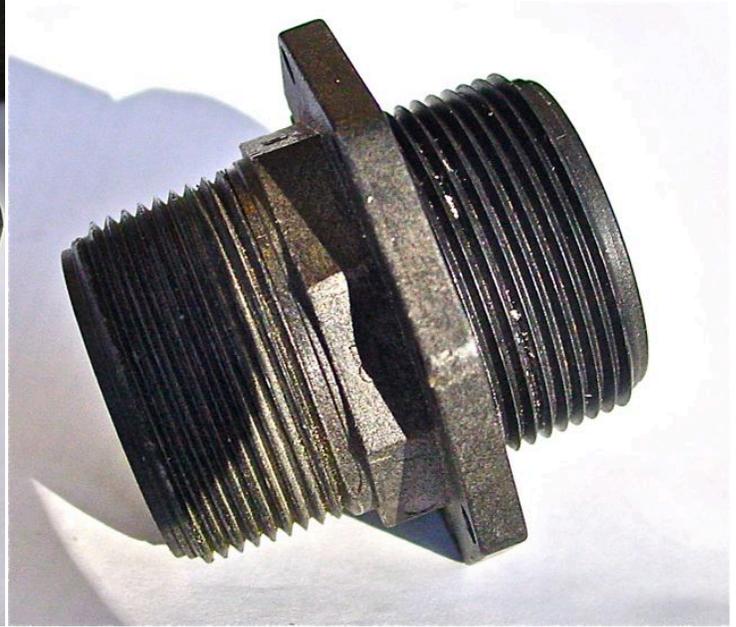
Pictures 6 and 7 show the black Turncouple nipple fitting seen in pictures 2 and 4. This fitting has over 100 hits and shows no cracks.

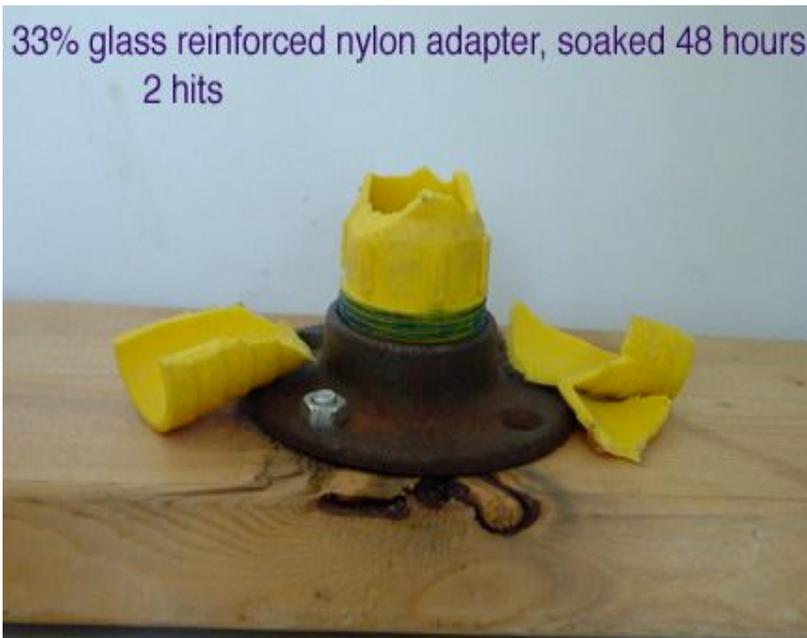
Picture 8 shows a 33% glass filled nylon part used by a leading boat builder as the tailpiece for their seacocks. It was immersed in water for 48 hours. It took only two hits to “shatter” this part.

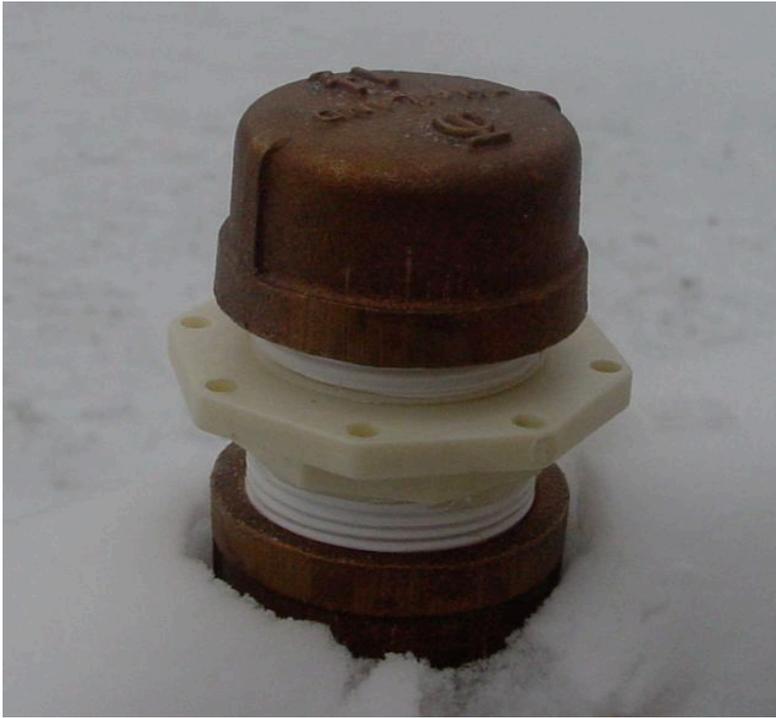
Picture 8

Pictures 8 and 9 are Turncouple fittings with bronze caps that were filled with water and set outside for 14 hours at -20 degrees. They provide proof that Turncouple molded Isoplast parts can withstand serious internal pressures without cracking.
