What do sacrificial keels mean in reality?

These are pictures of a 2007 Leopard 46' that hit a reef on the south coast of Cuba. The sacrificial keels did the job they were supposed to do.

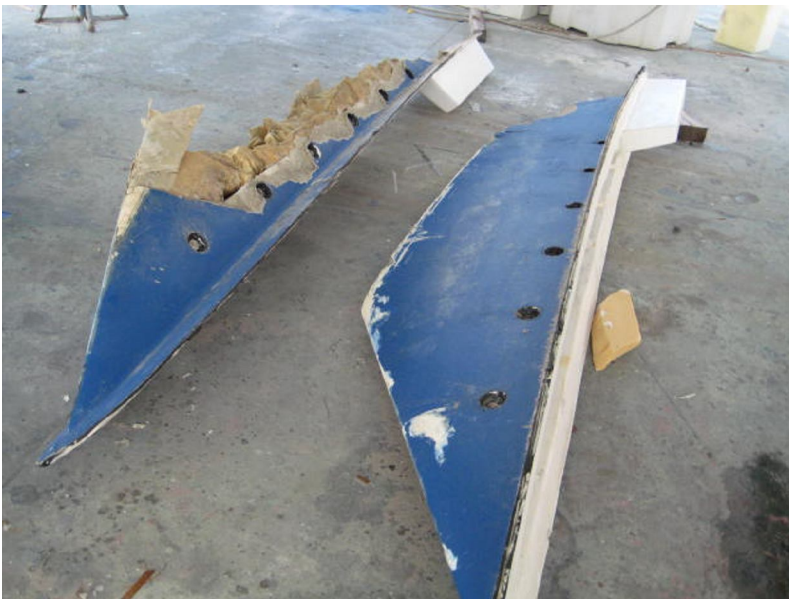
This is a picture of the hull after the 2 left-over's of the sacrificial keels were removed

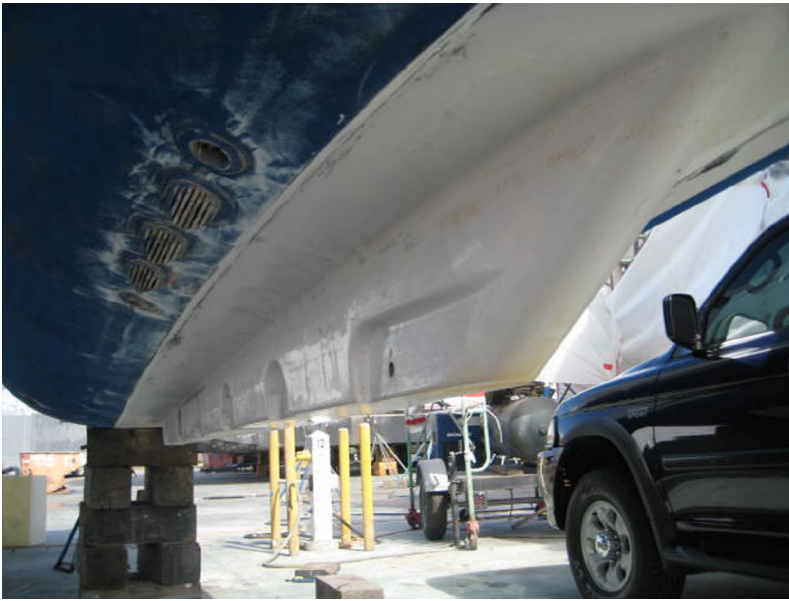
The boat sat bouncing on the reef from 10pm till daylight. The Cuban coastguard pulled the Leopard 46' off the reef and asked the owner if his yacht was made of steel. The coastguard said that no fiberglass yacht had ever sat on the reef for more than a few hours before being totally destroyed. He would not believe that it was a fiberglass yacht.

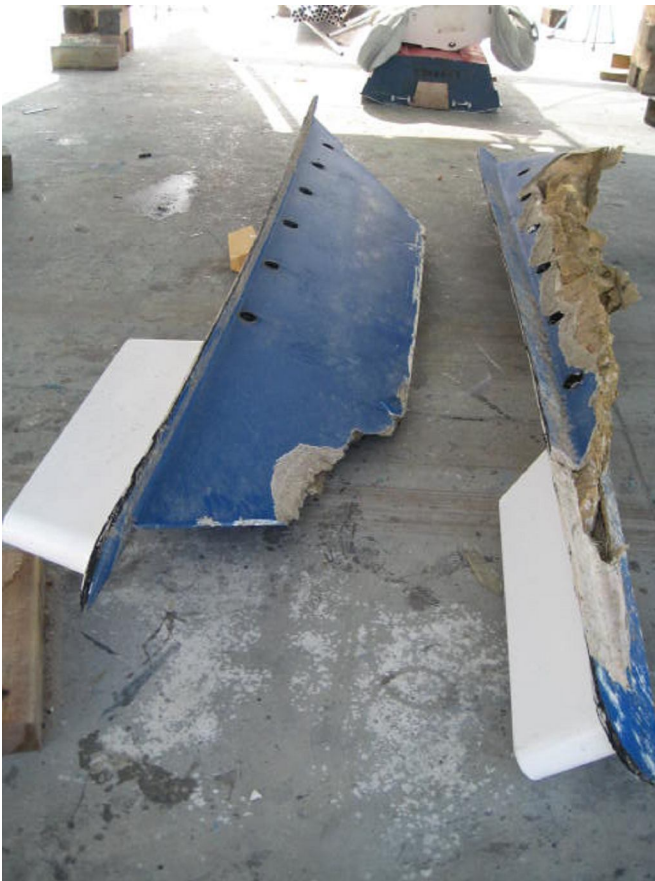
No damage to the male-female part and you can see the holes for the 6 thru bolts.

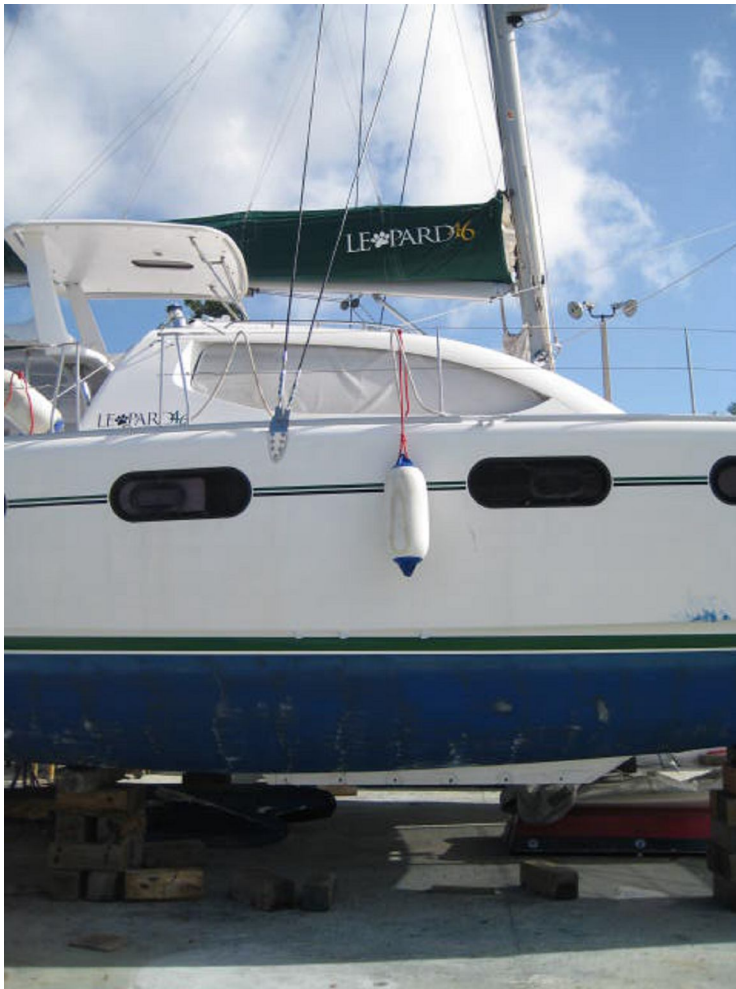
Shark attack or grounding?

2007 Leopard 46' with keels taken off.

Our service agents installed new sacrificial keels in Ft Lauderdale. It took only 2 weeks to get a set of new keels shipped out from Cape Town. In spring of 2008 this yacht left Ft Lauderdale for another Atlantic crossing and the owner is happily cruising the Mediterranean. (and there are very few reefs in the Med compared to the Caribbean!).
