Water damaged material in boat

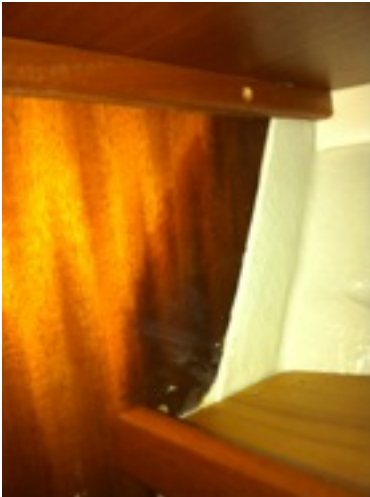
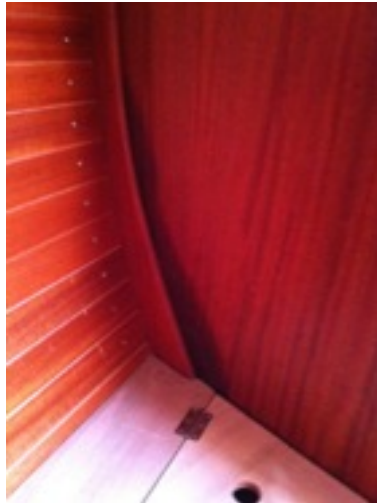
We just found out that the woods have soaked up a lot of water that made us puzzled. The boat have been on land because of Swedish winter. The winter that have not be so cold and very little snow.

Also the water damage is not spread from the "above", it's like in the "middle". The pictures is from the both sides of the water damage.

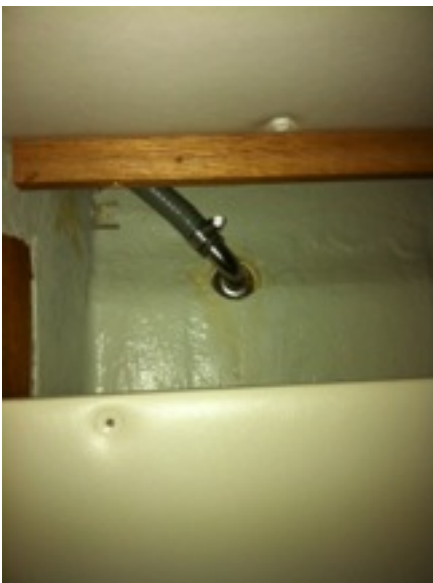
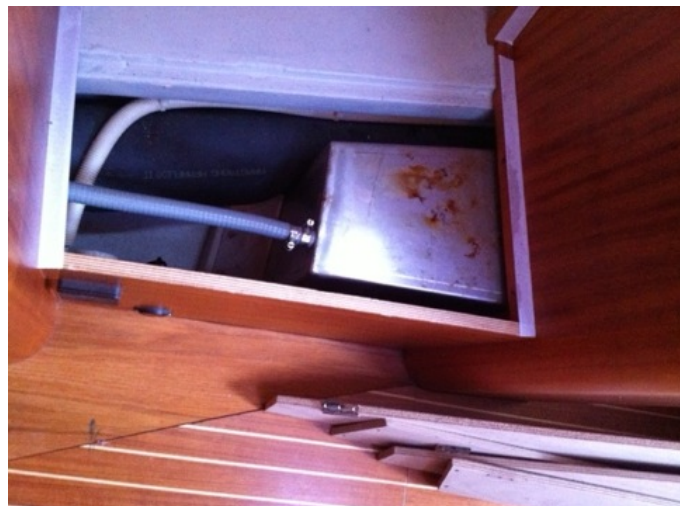
When opening up around the damage to find the cause of this effect I found some stuff. Above the area of water damage there is some kind of ventilation for the water tanks. This is our main suspects of leaking water, but we don't know for sure. Maybe there is some bigger "leakage" out of the ventilation when we "overflow" the water tanks? It was more like condensation on the "white" area, but remember that the boat have been on land with coverage over the boat.

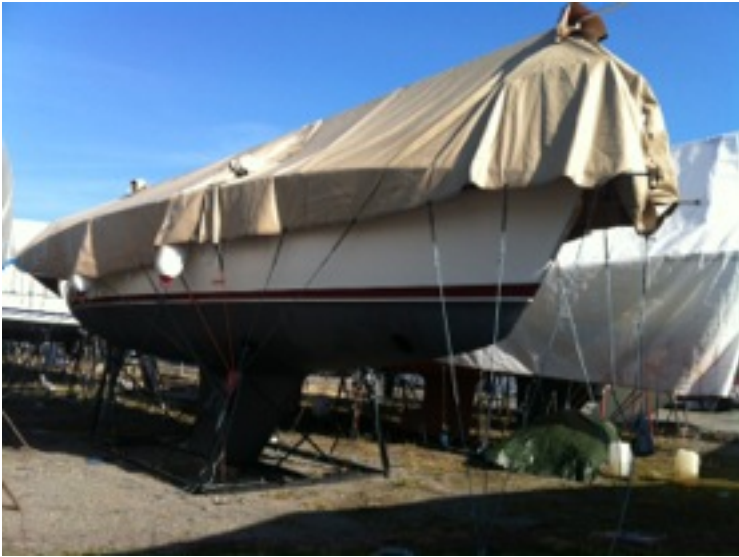
Boat coverage during winter, this side of boat are more exposed to the sun than the other side.

Winters are not so sunny, but maybe that can be a cause for condensation? Under the covers is the ventilation, so water can not be from the outside.
